5. MEMORIAL AUDITORIUM/GYMNASIUM COMPILATION OF BUILDING INFORMATION

5. MEMORIAL AUDITORIUM / GYMNASIUM EXECUTIVE SUMMARY

Winthrop Municipal Building Study
Archetype Architecture Inc.

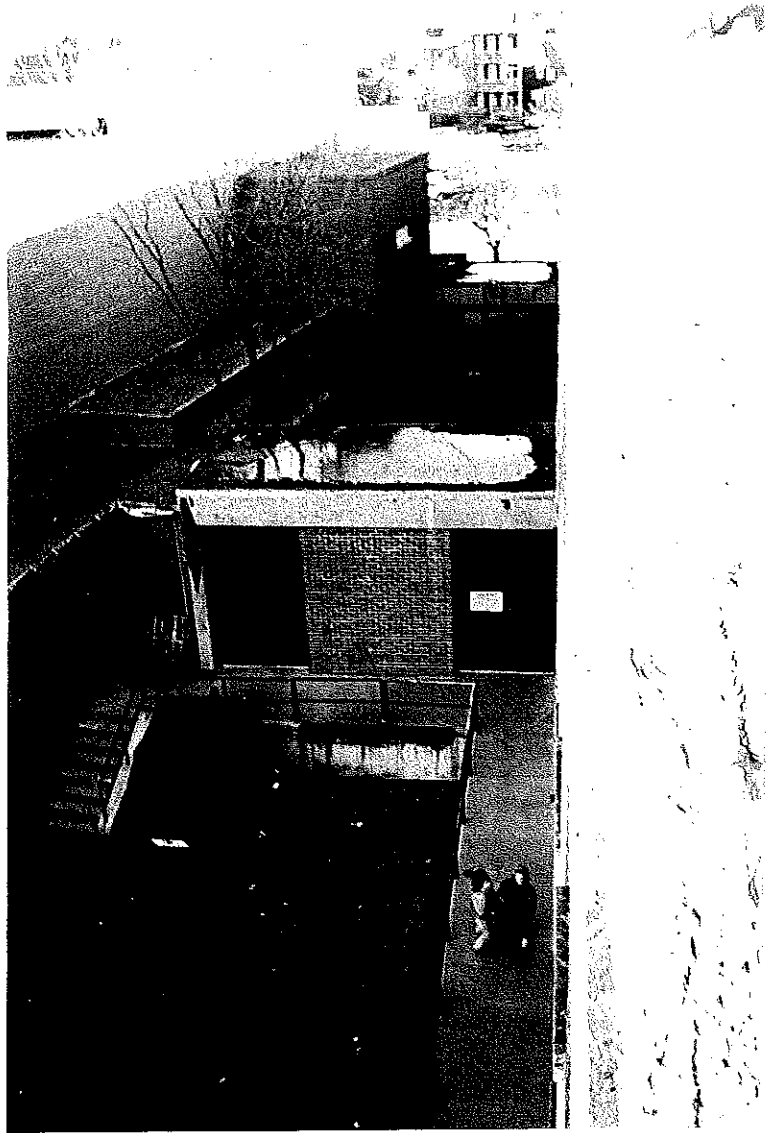
Observations: Roof not draining properly and in poor condition. Leak damage apparent in several locations. Though some patching has temporarily mitigated the problem
Copings and all roof top elements are in poor condition. Boiler room roof needs immediate replacement

Auditorium and corridor link roofs: inadequate roof drainage, flashing and coping in poor condition, roof is old. H.C. access ramp and doors are non-compliant.

<u>Year</u>	<u>Description</u>	<u>Qty.</u>	<u>Unit</u>	<u>Unit Cost</u>	<u>Amount</u>	<u>Total w/O&P</u>
A. BUILDING ENVELOPE						
1. ROOF SYSTEM						
1995	a. remove and replace roof system, all buildings	1	LS	\$120,000	\$120,000	
	SUBTOTAL				\$120,000	\$144,000

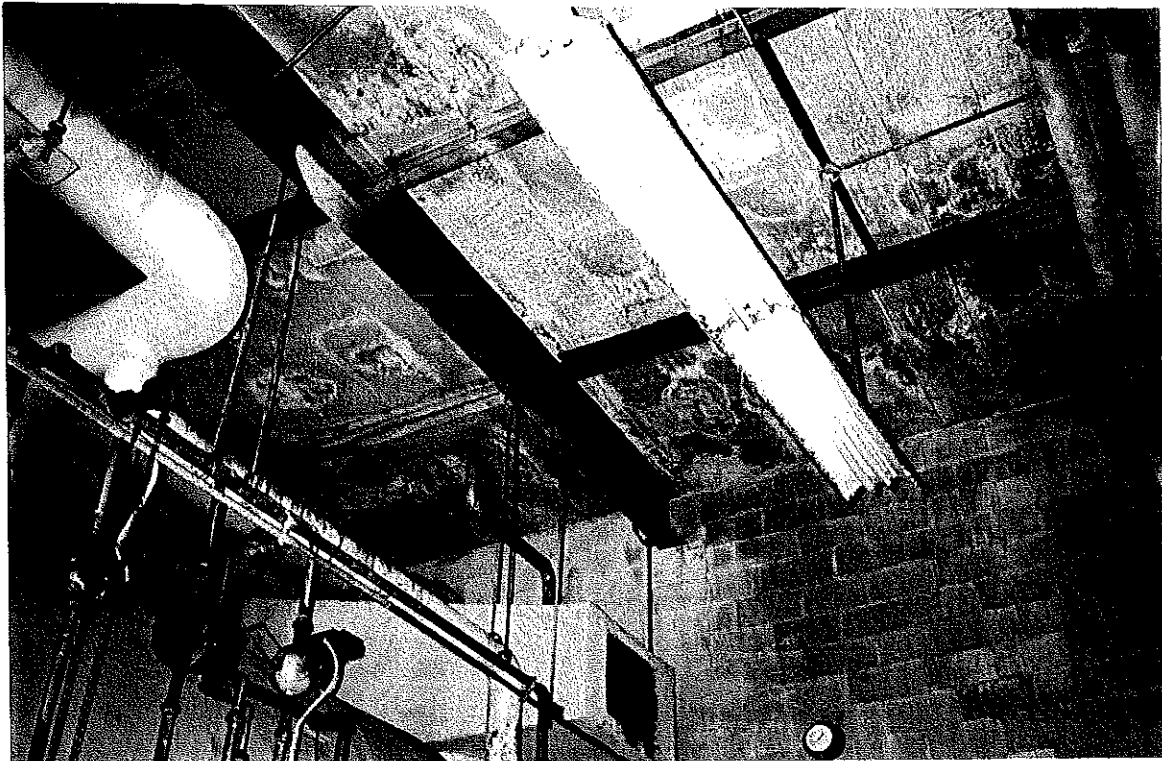
Observations: Boiler room windows system is rusted and has broken panes in numerous locations.

Boiler Room: roof leaks over heating and electrical equipment degradation of structure and mechanical and electrical components due to leaks and insufficient ventilation.

3. WINDOWS						
1996	a. rake and reseal all exterior door/window perimeters	1	LS	\$1,000	\$1,000	
1997	b. replace "little theater" windows	1	LS	\$6,000	\$6,000	
1997	c. provide operable window openings in gymnasium	1	LS	\$18,000	\$18,000	
1996	d. replace boiler room window system	1	LS	\$18,000	\$18,000	
	SUBTOTAL				\$43,000	\$51,600

3. HVAC						
1995	a. upgrade locker room ventilation	2	LS	\$1,500	\$3,000	
1996	b. replace boilers and components	3	LS	\$130,000	\$390,000	
1996	c. pipe insulation	1	LS	\$25,000	\$25,000	
1996	d. air compressor	1	LS	\$8,000	\$8,000	
1996	e. motorized damper for gen. room (asbestos abatement not included in above)*	1	LS	\$3,000	\$3,000	
	SUBTOTAL				\$429,000	\$514,800

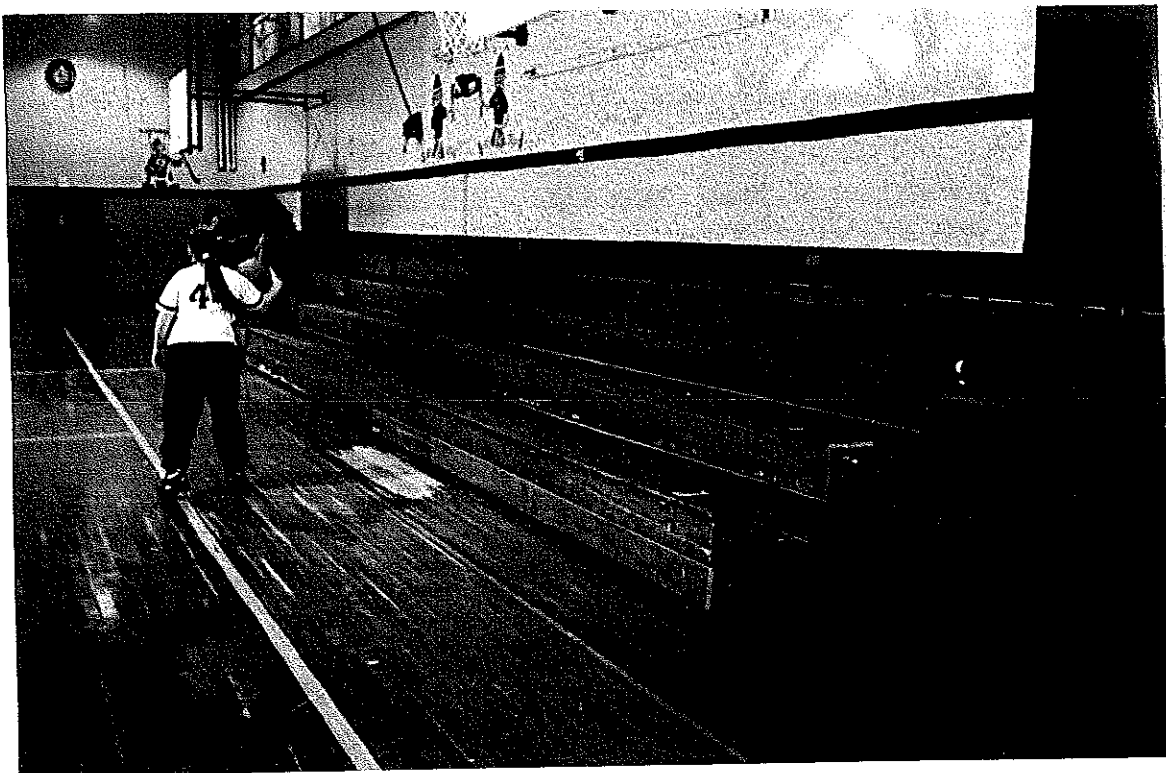
- b. Floors: Auditorium - concrete, painted.
Ancillary Spaces - V.C. tile in fair condition
Gymnasium - original wood floor has been damaged by former and current roof leaks and is in fair to poor condition.
Locker/Storage Rooms - in fair condition.

- d. Specialties: Original score board - in poor condition.
Bleachers old - in poor condition.
Locker room equipment is in poor condition.
Drinking fountains in poor condition.

Gymnasium: insufficient lighting, bleachers and floor are in poor condition. Inadequate ventilation.

2. INTERIOR SPACES						
1996	a. repair/refinish gymnasium floor	1	LS	\$10,000	\$10,000	
1996	b. repair wall around drinking fountains	1	LS	\$250	\$250	
1996	c. replace floor @ D.F. with resilient type (gym)	2	LS	\$600	\$1,200	
1998	d. paint auditorium	1	LS	\$18,000	\$18,000	
1998	e. paint other rooms	1	LS	\$6,000	\$6,000	
1996	f. repair cracks in block walls	1	LS	\$500	\$500	
	SUBTOTAL				\$35,950	\$43,140

<u>Year</u>	<u>Description</u>	<u>Qty.</u>	<u>Unit</u>	<u>Unit Cost</u>	<u>Amount</u>	<u>Total w/O&P</u>
3. FITTINGS & EQUIPMENT						
1998	a. new sound system in auditorium	1	LS	\$5,000	\$5,000	
1998	b. replace gymnasium bleachers (400 pers.)	1	LS	\$28,000	\$28,000	
	SUBTOTAL				\$33,000	\$39,600

4. ELECTRICAL						
1999	a. upgrade general lighting in auditorium	1	LS	\$6,000	\$6,000	
1996	b. upgrade lighting in gymnasium	1	LS	\$2,500	\$2,500	
1999	c. upgrade stage lighting, new control panel	1	LS	\$30,000	\$30,000	
	SUBTOTAL				\$38,500	\$46,200
