4. WINTHROP MIDDLE SCHOOL COMPILATION OF BUILDING INFORMATION

WINTHROP MIDDLE SCHOOL

BUILDING DATA INVENTORY

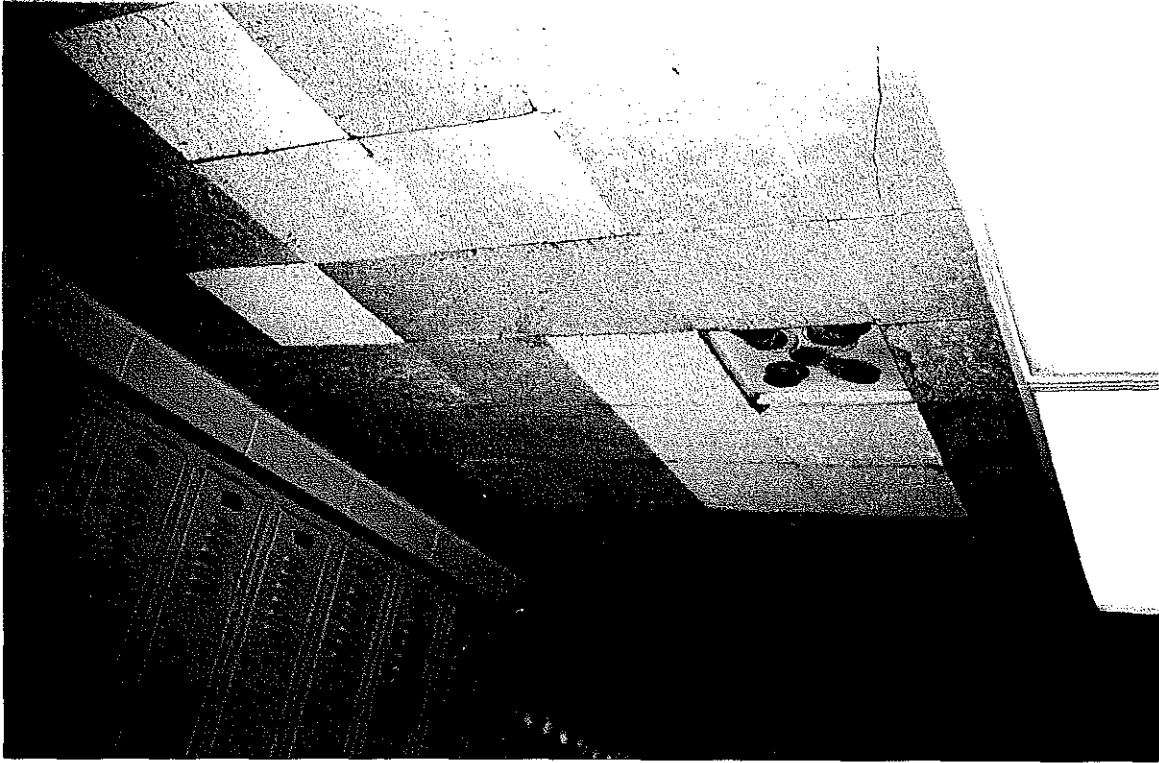
- c. Ceilings: A. T. Ceiling system through-out 1x1 tiles with limited access points and small 1x1 hatches and is in fair to poor condition throughout.
Recurring leaks from heating system has damaged ceiling in many locations.
Hallway ceilings are unusually low and prone to damage.
Upper level hall ceiling is discolored and patchy due to air being drawn through this ceiling and into the plenum space above.
Damage observed at ceiling and soffit above stairways.

Second level ceiling: evidence of roof and heating system problems ceiling system is decrepit and problematic for access to systems above.

B. BUILDING INTERIOR						
1 CIRCULATION AREAS						
1997	a. replace ceiling in corridors (after roof & heating systems work)	5000	SF	\$5	\$25,000	
1995	b. repair soffit at stair, first floor	1	LS	\$300	\$300	
	SUBTOTAL				\$25,300	\$30,360
2 INTERIOR SPACES						
1997	a. repair damaged ceilings	15000	SF	\$3	\$45,000	
1996	b. V.C. tile repairs	1000	SF	\$6	\$6,000	
1996	c. replace toilet room door louvers	2	LS	\$60	\$120	
1996	d. repair terazzo floor cracks, holes	250	SF	\$10	\$2,500	
1998	e. replace ceiling @ lower level	4500	SF	\$3	\$11,250	
1997	f. replace kitchen ceiling	2000	LS	\$4	\$8,000	
	SUBTOTAL				\$72,870	\$87,444

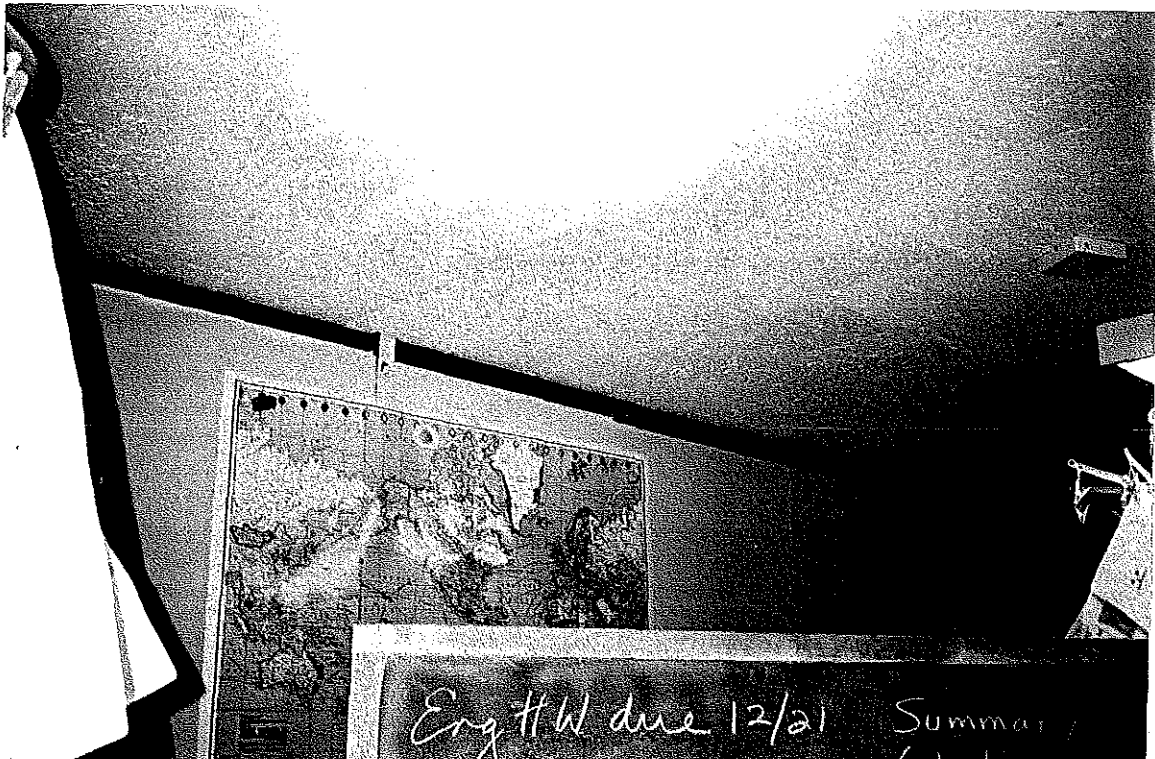
- a. Walls: Painted concrete block in fair to good condition.
Numerous demountable partitions between classrooms:
Room partition system has required reinforced anchor straps at top.
Are slipping out of alignment.
Don't accept attachment of additional classroom specialties or wiring for electrical & communication.
Have damaged finishes.
- b. Floors: V.C. Tile in most classrooms - in fair condition.
Poor condition in areas where leaking has occurred.
Carpet in library, office/admin. in fair condition overall.
- c. Ceilings: Acoustic tiles 1x1 in fair to poor condition.
Numerous repairs required due to leaks, particularly at perimeter of building and in upper level hallways damaged by heating system leaks.
System should be inspected to assure that ceiling supports are not being diminished by corrosion.

Typical classroom: demountable partition system failure. Panels have slipped out of alignment leaving open gaps at ceiling. Metal strip added to anchor partitions to slab above.

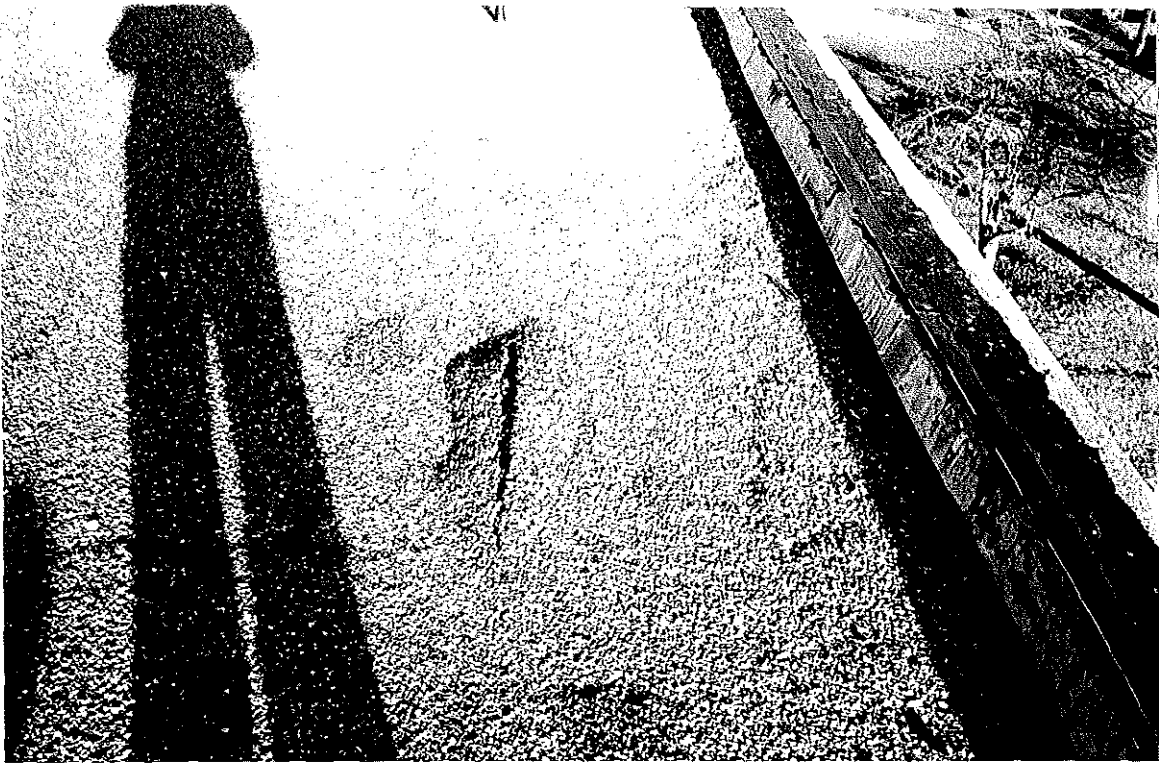
observations: Roof system is well past expected service life.
Surface is hard and brittle with some areas of ponding.
Flashings around roof penetrations are inadequate.
Pitch pockets have voids.
Perimeter flashing is inadequate by design with the edge merely adhered to top surface of concrete curb and is failing in a number of locations.
Roof over annex connector is not draining properly.
2. Wall System: Exposed concrete frame and brick/masonry infill panels with minimal insulation.

Old roof system: open gaps in flashing, no coping, protection/cover, roof is hard, wavy, cracked.
Minimal or no insulation, roof penetration flashing is failing.

- Replace the roof system
- Overhaul heating and ventilation system
- A separate facility for new boilers to Middle School should be considered in order to disconnect this school from the older adjacent buildings.

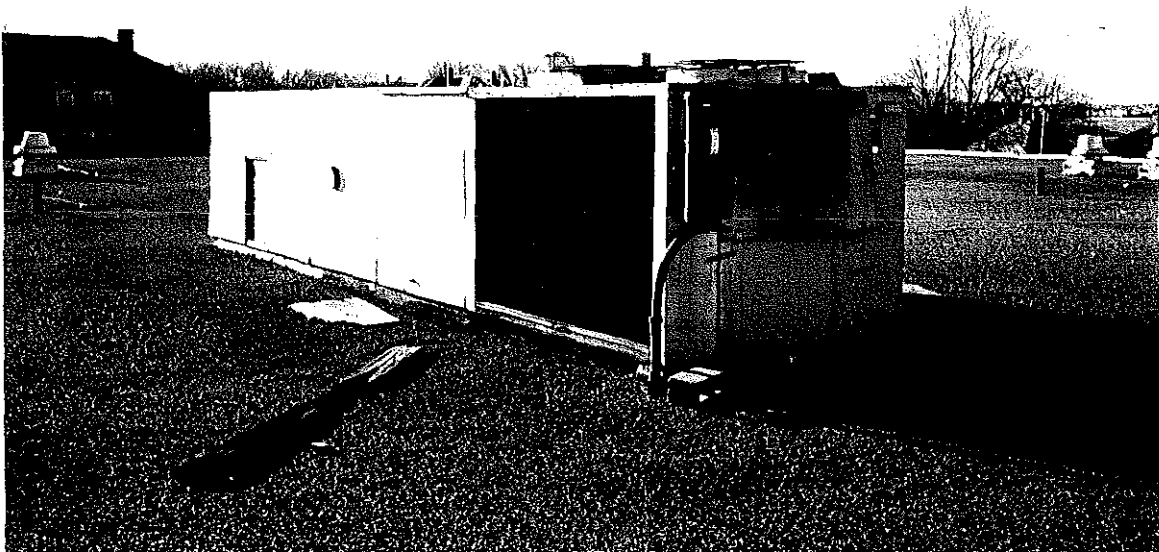
Old roof top air handler is on partial operation only, improperly designed roof mounting,
penetration pitch packets failing.

C. BUILDING SYSTEMS					
	1 FIRE PROTECTION					
	SUBTOTAL					
	2 PLUMBING					
1996	a. replace flushometers	24	LS	\$200	\$4,800	
	SUBTOTAL				\$4,800	\$5,760
	3 HVAC					
1996	a. bathroom ventilation	6	LS	\$800	\$4,800	
1996	b. replace rooftop unit	1	LS	\$45,000	\$45,000	
1996	c. upgrade unit ventilation controls(1,200/rm)*	30	LS	\$1,200	\$36,000	
1996	d. boiler replacement anticipated* (see Mem. Aud./Gym)					
	SUBTOTAL				\$85,800	\$102,960
	4 ELECTRICAL					
	SUBTOTAL					
	5 SECURITY & COMMUNICATIONS
